# Peripheral Intravenous Cannula Fracture: Increasing Incidence and Management

**Abstract Background:** Peripheral Intravenous Cannulation is a routine invasive procedure in clinical practice with various associated complications including cannula fracture. **Objective:** To evaluate the incidence of peripheral intravenous cannula fracture and its management. **Materials and Methods:** This was a prospective cross-sectional study conducted at the University of Port Harcourt Teaching Hospital between April 1, 2019, and December 31, 2021. A data collection tool designed specifically for the study was used to obtain information on the size of the cannula, cadre of doctor that inserted the cannula, the brand of the cannula, history of reinsertion of the introducer needle during cannulation, duration of the intravenous cannulation, time of presentation and successful retrieval rate. **Results:** There were 15 cases of broken peripheral IV cannulae. The patients were aged 25-44years, consisting of 1 (6.67%) male and 14 females (93.33%). All the cannulae were 16G (gray) and were inserted mostly preoperatively for caesarean section, 7 (46.67%) of them were inserted by consultants, 4 (26.6

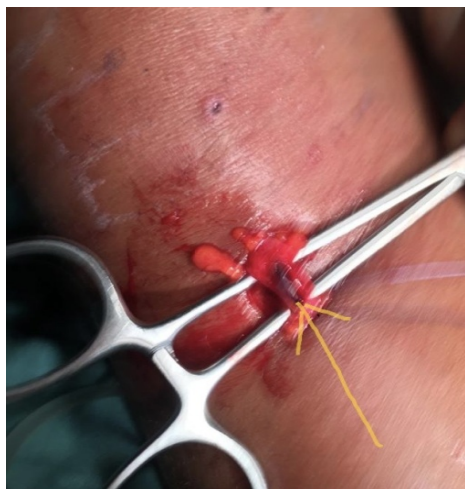
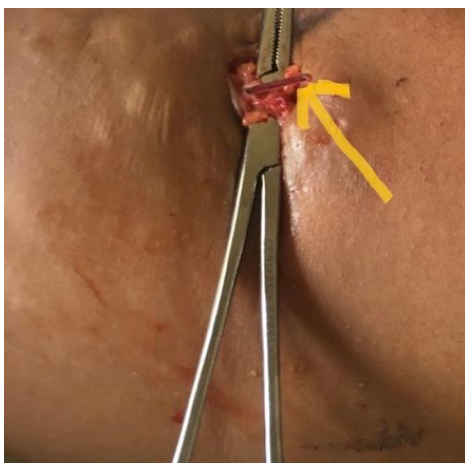
The procedure for the retrieval of fractured peripheral intravenous cannula identified by palpation before retrieval in two patients is displayed in Figure 1. The proximal and retrieved distal segments of a fractured peripheral intravenous cannula from two different patients is shown in Figure 2.

**Figure 1.** Operative sessions for two different patients with the fractured peripheral intravenous cannula segments sticking out just before retrieval

Following notification of PIC fracture by the managing team, the cardiothoracic and vascular surgery unit evaluated the patient. Thereafter, a tourniquet was applied proximal to site of cannula fracture, to limit the chances of migration. Within a 30-minute period, the fractured segments for most of the reported cases were confirmed by palpitation, though some required the use of a Duplex scan. However, when the fractured segment was not readily palpable, marking of the site was done using a duplex scan and the patient was taken to a procedure room. Under aseptic conditions and local anaesthesia, a skin incision was made at the site and venotomy was carried out. The fractured segment was retrieved, with the venotomy repaired or ligated depending on the size of the vein after heparinized saline irrigation.

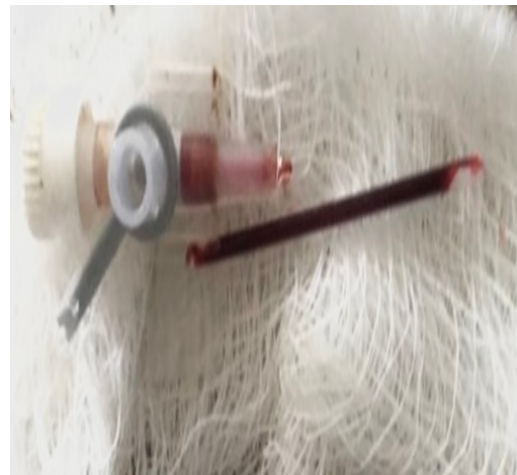
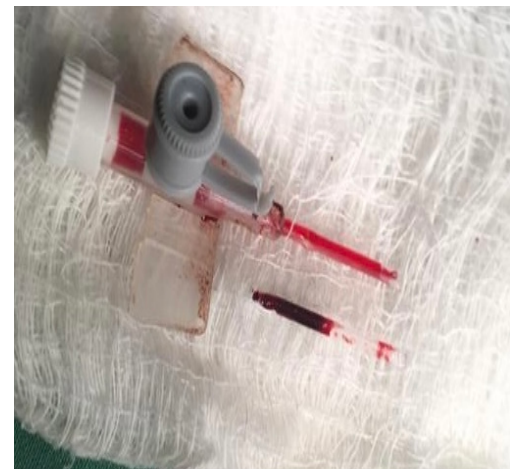
**Figure 2.** Proximal and retrieved distal segments of a fractured peripheral intravenous cannula from two different patients

Inexperienced insertion technique, several failed attempts at cannulation and structural defect of the cannula have been reported to cause PIC fractures [14]. Similarly, intravenous cannulations carried out under emergencies are at higher risk of resulting in complications [11]. Another factor that may cause cannula fracture is the continuous attempt to remove the device by the patient [5]. However, in this study all the 16G cannula that were fractured were from the same manufacturer, which further raised suspicion about the integrity of the cannula. The incidence of cannula fracture drastically reduced when another brand of cannula was used. Hence, it was evident that cannula integrity was also a risk factor for PIC fracture.

Though, technical error during insertion could be a contributing factor, the quality of the cannula in this study appeared to have contributed more to the increased rate of cannula fracture as the rate reduced drastically when the brand of peripheral intravenous cannula was discontinued. However, timely detection, reporting and intervention were key to successful retrieval as the few that migrated were observed among those that presented late.
